Evaluation Tests Of Pop-Up Traffic Sentinel Manufactured By
Terra Engineering Co.

September 1968

State of California
Department of Public Works
Division of Highways
Materials and Research Department
5900 Folsom Blvd., Sacramento 95819

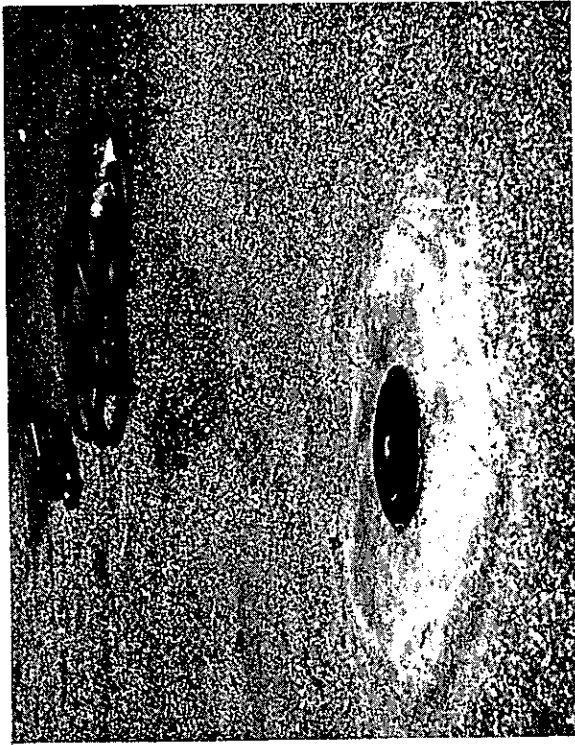
Before the impact test and with the tube in the down position, the installation was covered with sand and gravel and water was poured onto it. It was satisfactorily operated several times, up and down at an air pressure of 35 psi. The unit is designed so that a wiping action on the outer and inner surfaces of the tube takes place as it is extended and lowered, thus minimizing the passage of foreign material into the unit where it could cause jamming. On the particular model tested, the outer seal had excessive clearance and did not wipe satisfactorily. Although no operating problems were experienced, the manufacturer plans to correct the clearance on the future model.

Moisture and Grit Test - Tube Extended

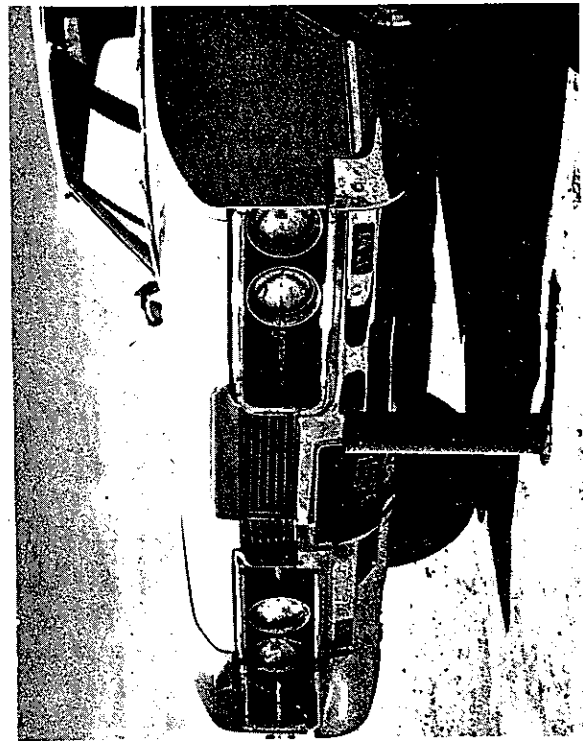
Installation and Equipment
